TREATMENT OF PERFORATED CANALS: A CASE REPORT

This article describes a successful management of a cervical perforation that occurred during routine endodontic therapy.

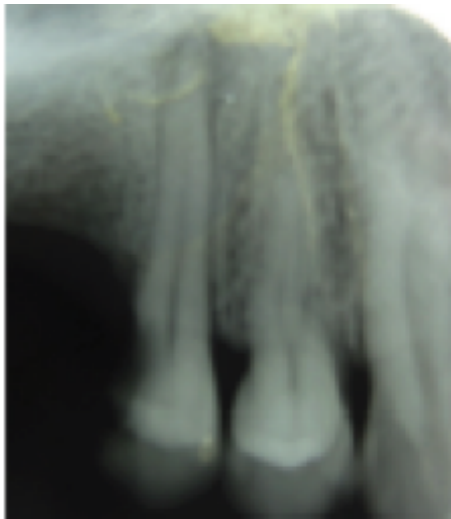
Radiographic examination revealed deep caries involving the pulp wrt 25. Widening of PDL space was seen in the apical area of 25 (Figure 1). The tooth did not respond to vitality testing. A provisional diagnosis of symptomatic apical periodontitis wrt 25 was made.

Figure 1. Radiographic examination.

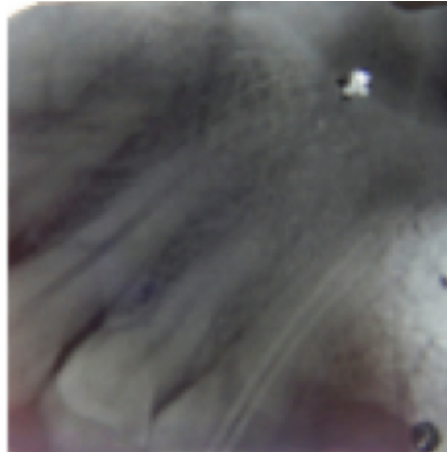
During endodontic access opening a cervical perforation resulted on the mesial side due to misdirection of the bur (Figure 2). Tooth was isolated,

Figure 2. Misdirection during endodontic access opening.

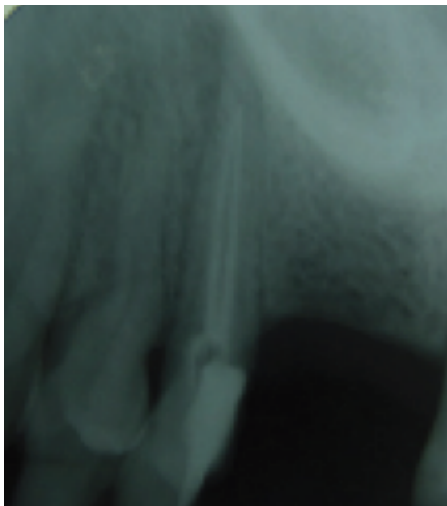
Figure 3. GIC over the perforated site and condensed along the adjacent wall.

bleeding was controlled and disinfection was brought about using chlorhexidine. The canal was dried gently using hemostatic agents, following which GIC was placed over the perforated site and condensed along the adjacent wall (Figure 3). After this routine root canal treatment was done.

In the case presented the perforation was supracrestal and wound contamination was prevented. The use of a biocompatible material like GIC, which provides good adhesion, was able to seal the defect immediately.
